2000 kg Coram Bottle Jack Repair

Richard Brook, last modified: 14/10/2023

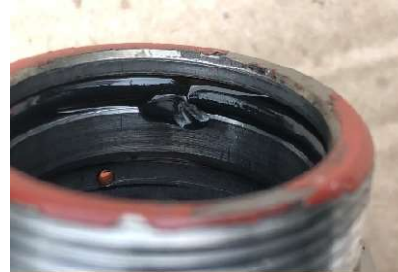
This jack was leaking where the ram emerges from the working cylinder at the top. "You've got an oil leak at the off-side front somewhere" said the MoT tester. Here's why...
